STRUCTURE NO. 1 - WILLIAMS CREEK

Structure Number 1 - Williams Creek Dam
(MO 10728), Missouri - Kansas City Basin,
Clay County, Missouri. Phase I Inspection
Report.

PREPARED BY: HOSKINS-WESTERN-SONDEREGGER, INC.

11 AUG 1978

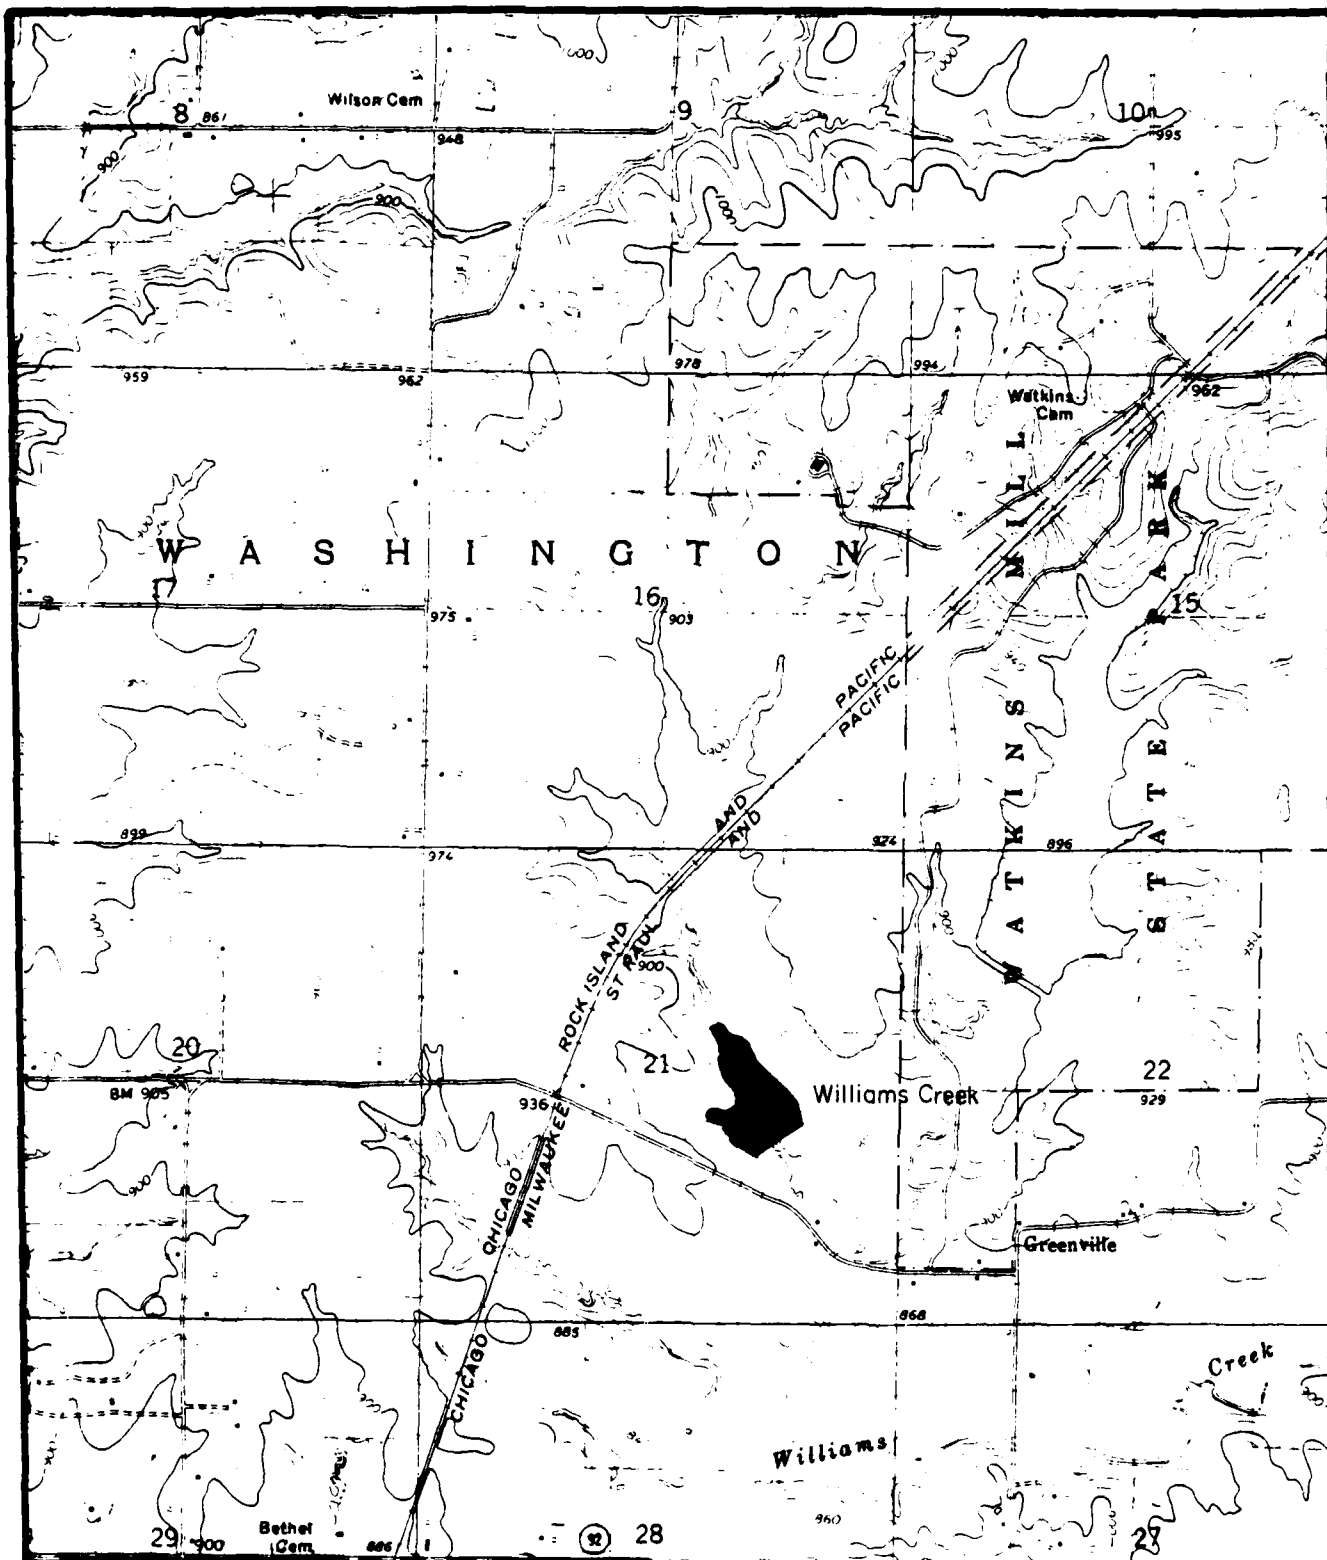
STRUCTURE No. 1
WILLIAMS CREEK
VICINITY TOPOGRAPHY
PLATE 1

(1) This dam is an earth fill located on an unnamed subtributary of Williams Creek, approximately 2000 feet upstream from its confluence with a larger tributary. The larger tributary is dammed approximately 5000 feet upstream from this confluence. The quadrangle map on Plate 1 shows the location of Williams Creek Watershed Structure No. 1.

b. Location. The dam is located in the northeast portion of Clay County, Missouri, as shown on Plate 2. The dam and the lake it forms are located in the SE $\frac{1}{4}$ of Section 21, T53N, R30W, as shown on Plate 1.

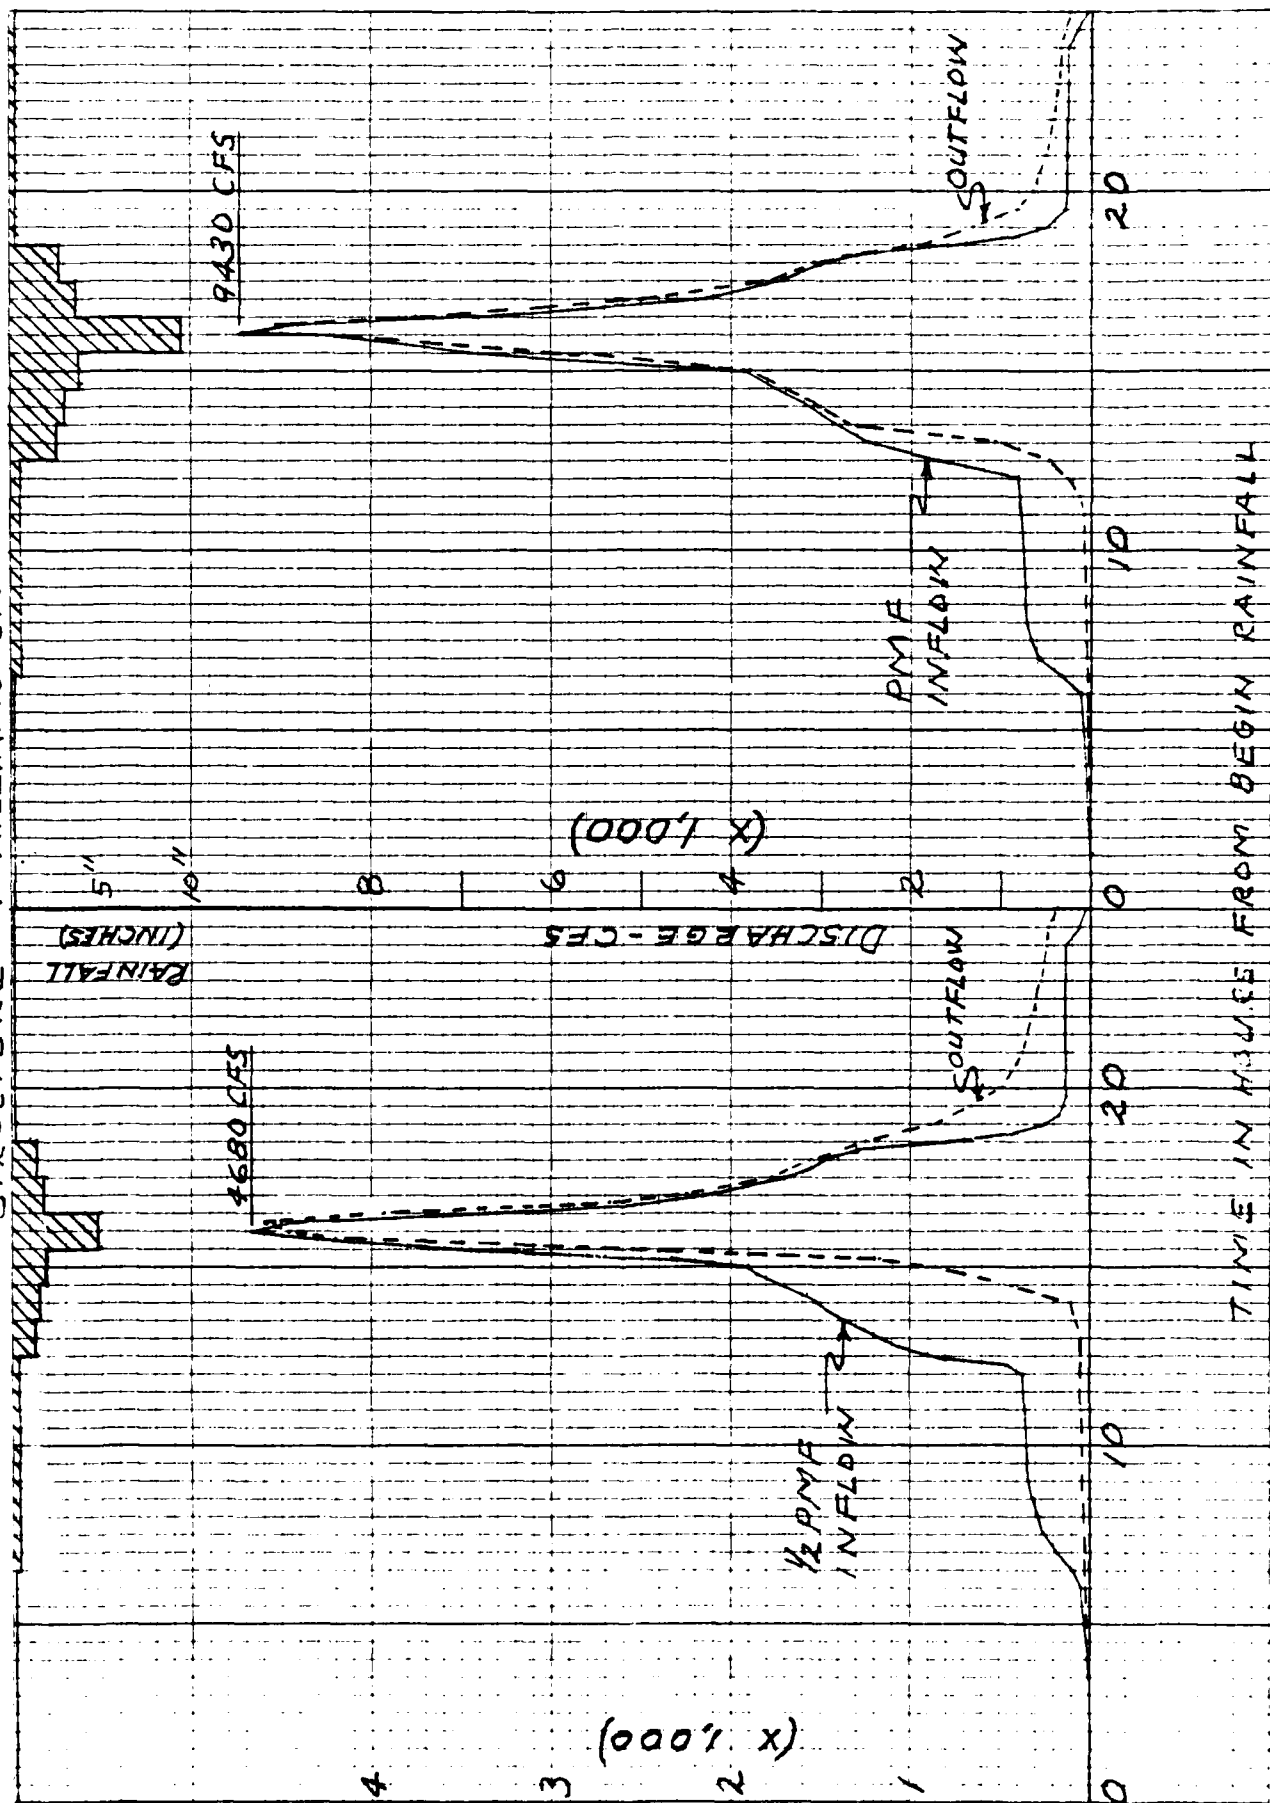
STRUCTURE #1-WILLIAMS CR.

3. Floods were routed through the reservoir using the TR-20 program to determine the capabilities of the spillways and dam embankment crest. The storm rainfall patterns, inflow hydrographs and routed outflow hydrographs are shown on Plate D1.
